# PROJECT REPRESENTATIVE'S DAILY REPORT

Pg. 1  
Report No. 041  
Date: 2014-10-15  
Day: Wednesday

**Project:** Renovation and Addition to Tewksbury Town Hall

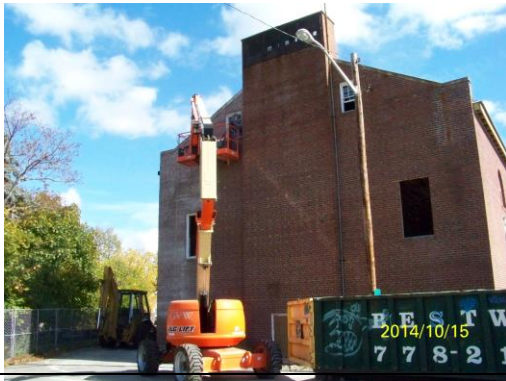
Photo showing a mason working on the west elevation of the meeting hall.

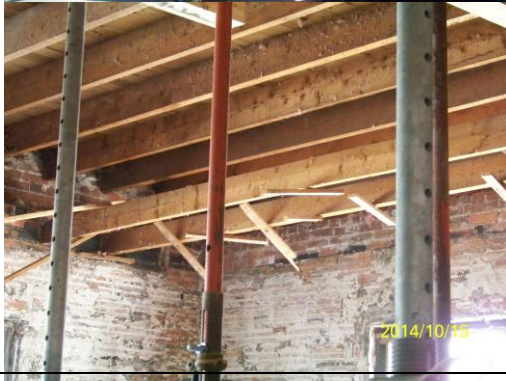
Photo showing some of the ceiling framework removed. This is in the north wing, first floor.
